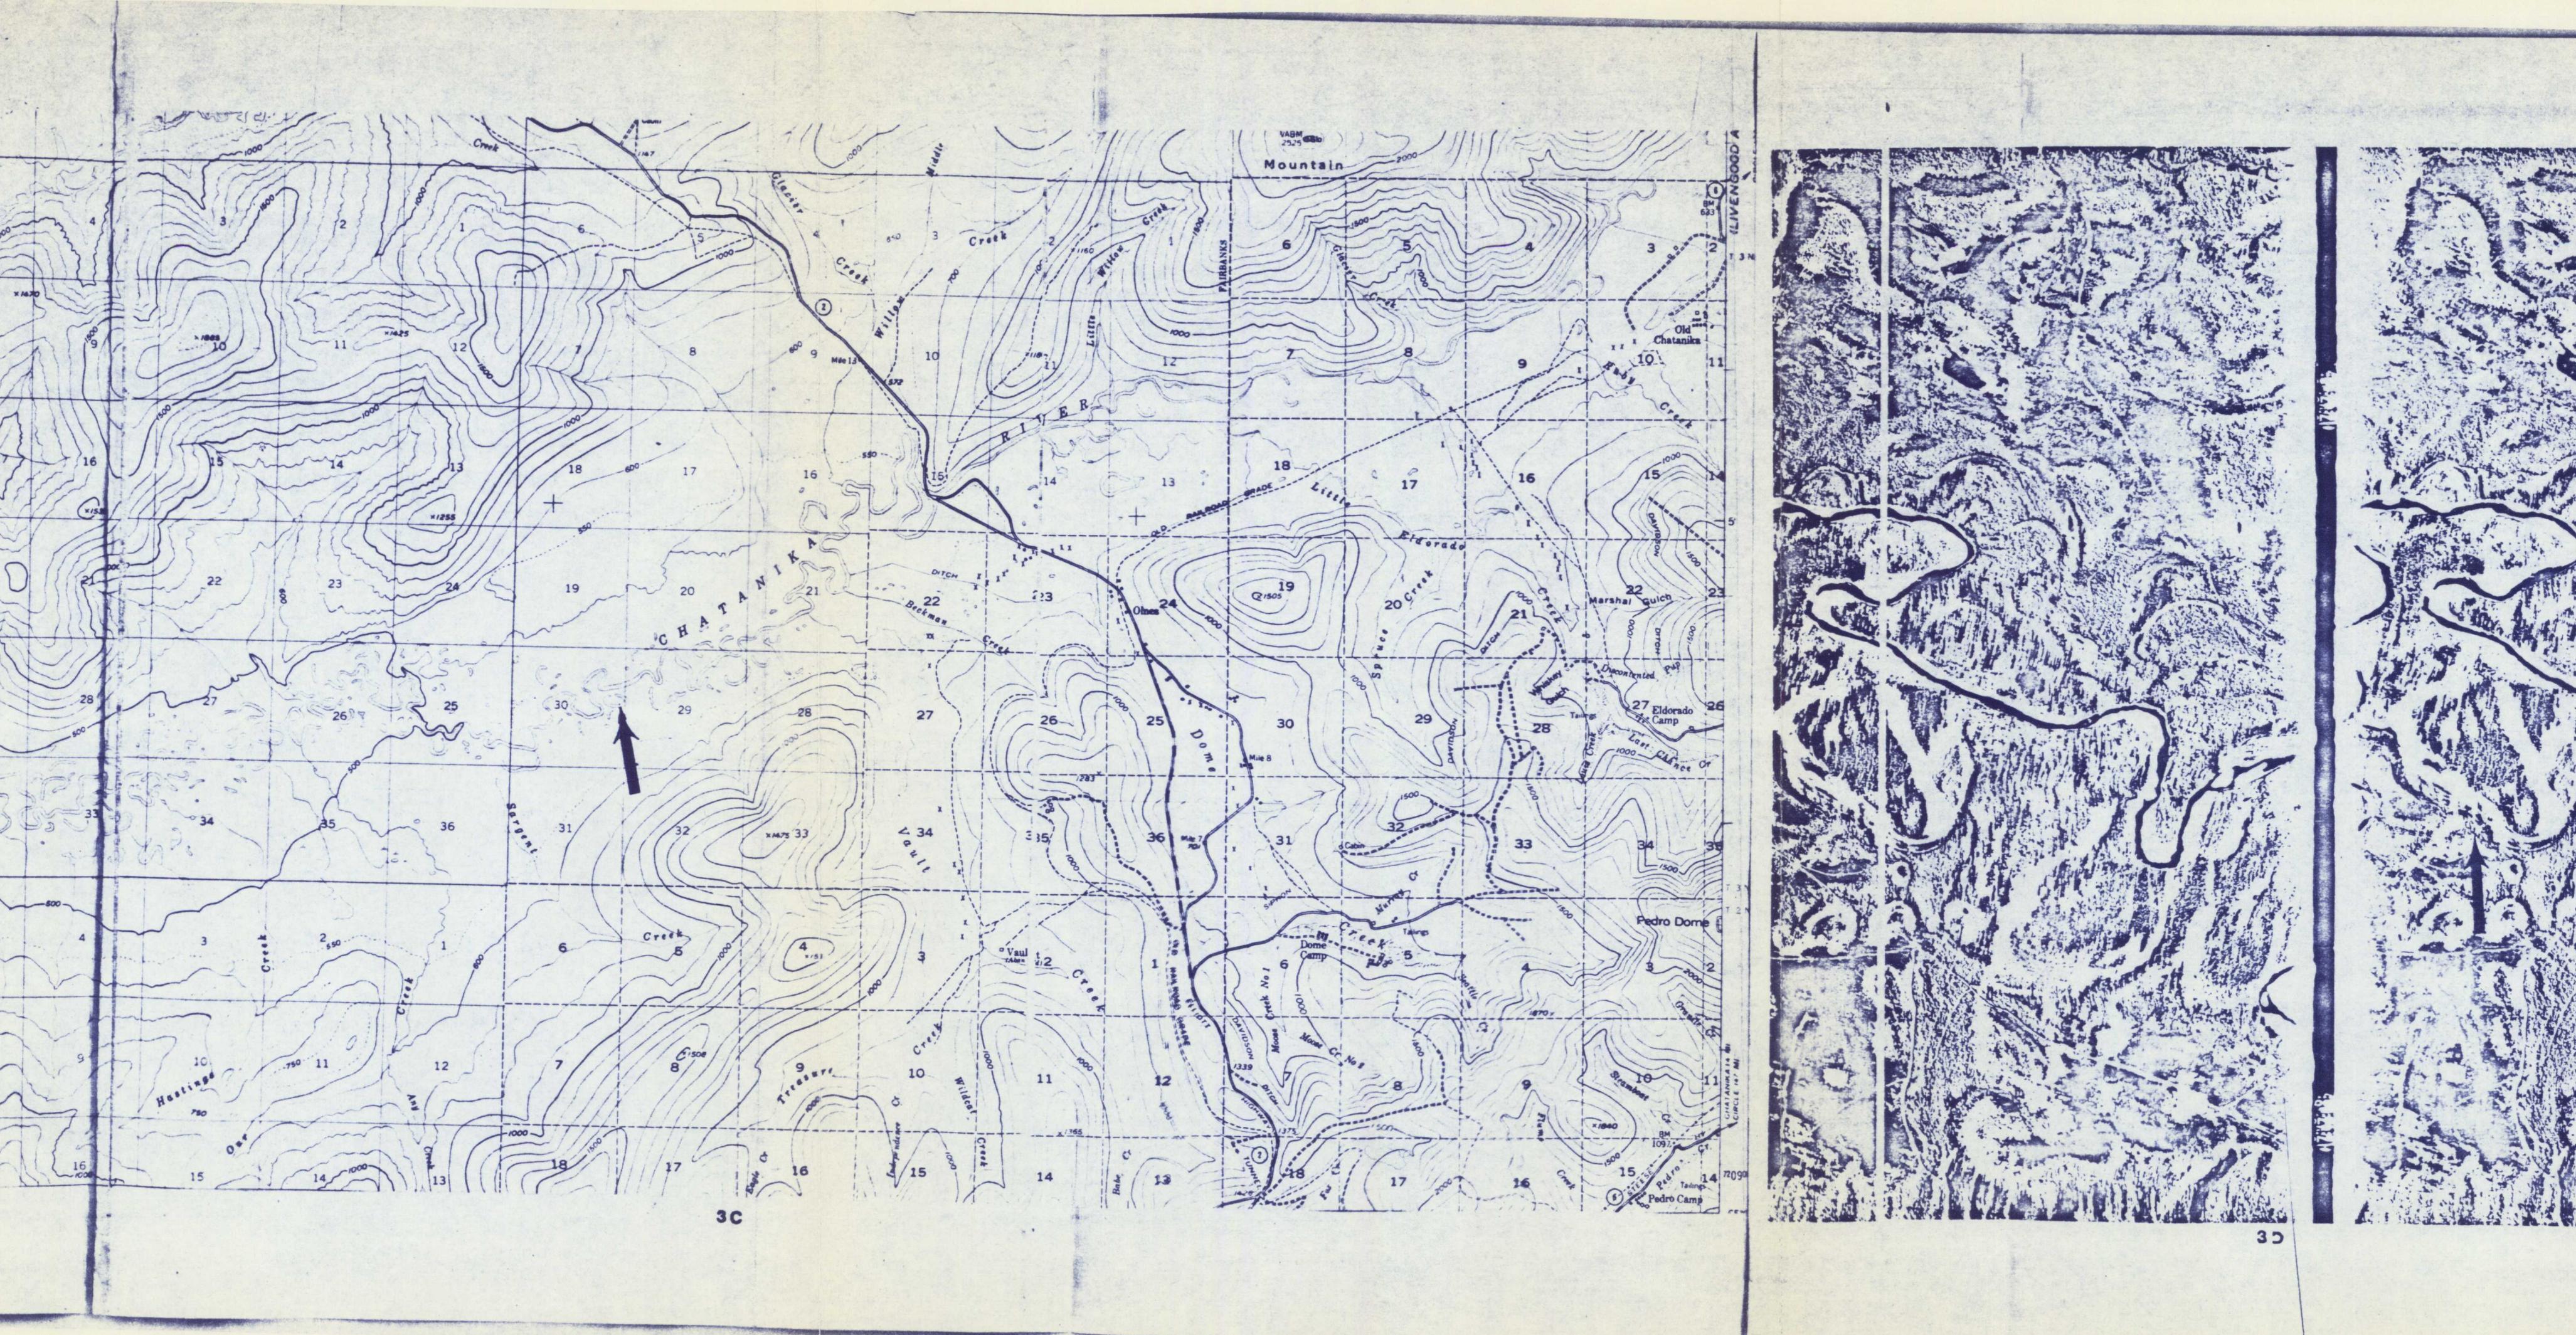
Figure 3C. Livengood (A-2) quadrangle sheet. Arrow points to icing site.
